EXPEDITION 'JOB 74'

An overview of Expedition 'Job 74' which carried Explorers Club Flag #118 to the wrecks of HMS *Prince of Wales* and HMS *Repulse*, South China Sea, May 13th – May 25th 2007.

Report compiled and submitted by expedition member and flag applicant Kevin Denlay, Fellow International 1998. (Page 1 of 28)

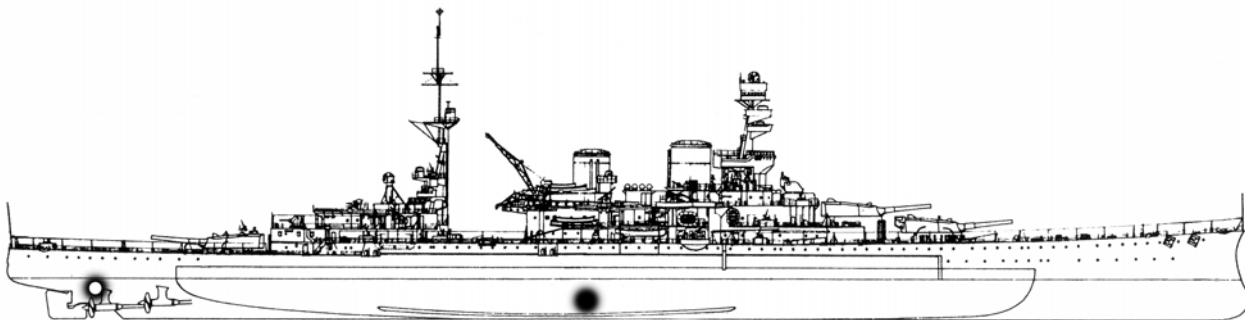
Expedition 'Job 74' could confirm only two hits as shown, although as stated previously the two port side amidships hits *may* have been buried beneath the seabed at the time the expedition was conducted. However, the suspected hit abreast the rear turret is *not* there.
Black solid circle on hull = Confirmed starboard side torpedo hit.
Black outline circle on hull = Confirmed port side torpedo hit.

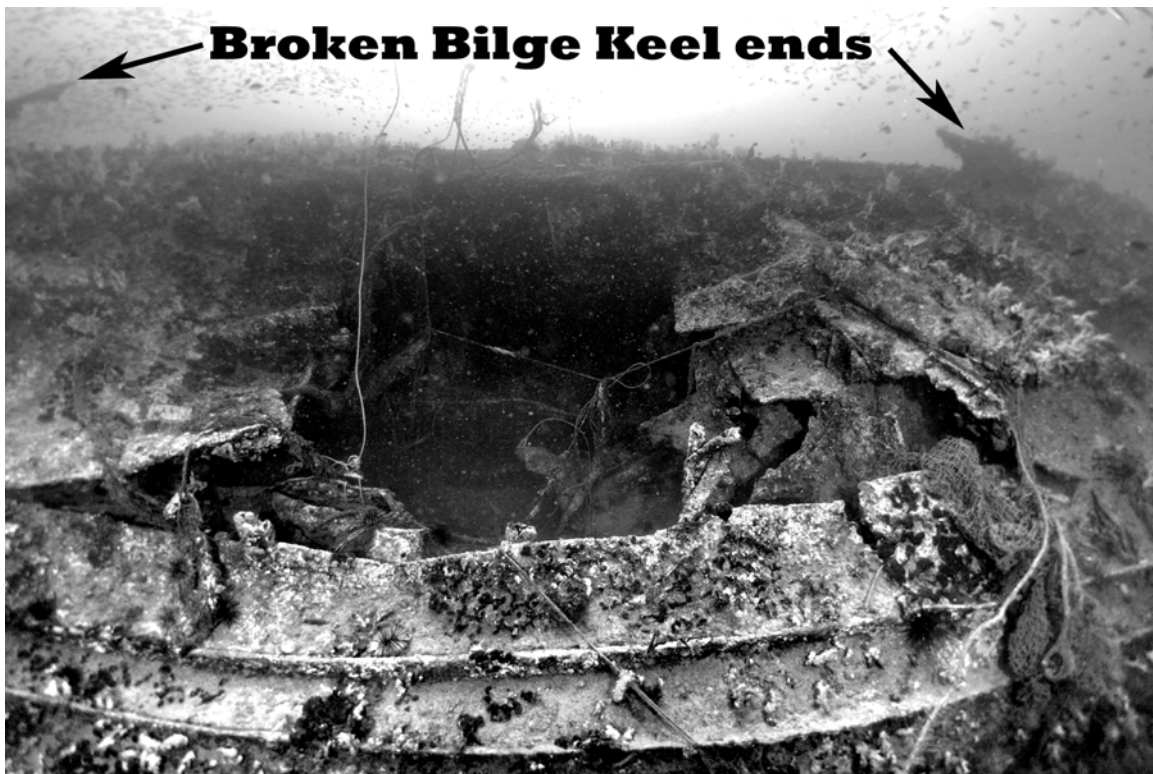
Photo is of the starboard amidships hit on *Repulse*, which is approx 4m high x 6m wide. Top left and right can just be seen the remains of the destroyed bilge keel. (NOTE; the distortion/curvature seen at the bottom of photo is from the use of a Fisheye - 180° - lens.)

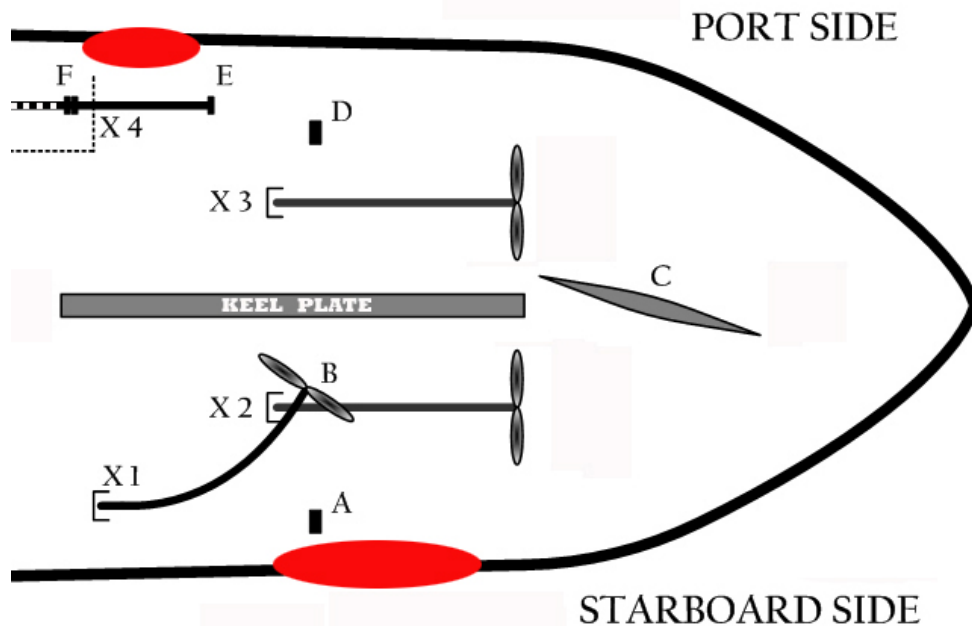
H.M.S. PRINCE OF WALES Upside-Down Stern Section - Propeller Shafts Details From Survey by Divers May 2007

- A) Remains of the *outer* strut of the outer Starboard shaft A-Bracket.
 - B) Outer Starboard propeller shaft is bent inboard and its propeller rests 'atop' the inner shaft just aft of where inner shaft exits the hull at the stern tube gland.

- C) Rudder is angled to port at approximately 20 degrees.
 - D) Remains of the *inner* strut of the outer Port shaft A-Bracket.
 - E) Flange on end of outer Port shaft (propeller, A-Bracket and shaft length missing).

- F) The flange that joins two lengths of shaft that can be seen when looking forward along the shaft inside the damaged stern tube receptacle.
- X1, X2, X3. Positions where shafts exit the hull at the stern tube gland.
X4. Where the Port shaft stern tube gland exit point is *thought* to have been. Severe damage to this area has made marking the exact position, in relation to the remaining shaft, difficult. Red elliptical areas on either side show position of torpedo hits/holes. Hole on Port is approximately 4 mts high by 6mts wide and was the first hit the ship took, while the hole on Starboard is approximately 4mts high by 11mts wide and was the fourth, or last, torpedo hit the ship took. (Time between hits, approx. 40 minutes.)

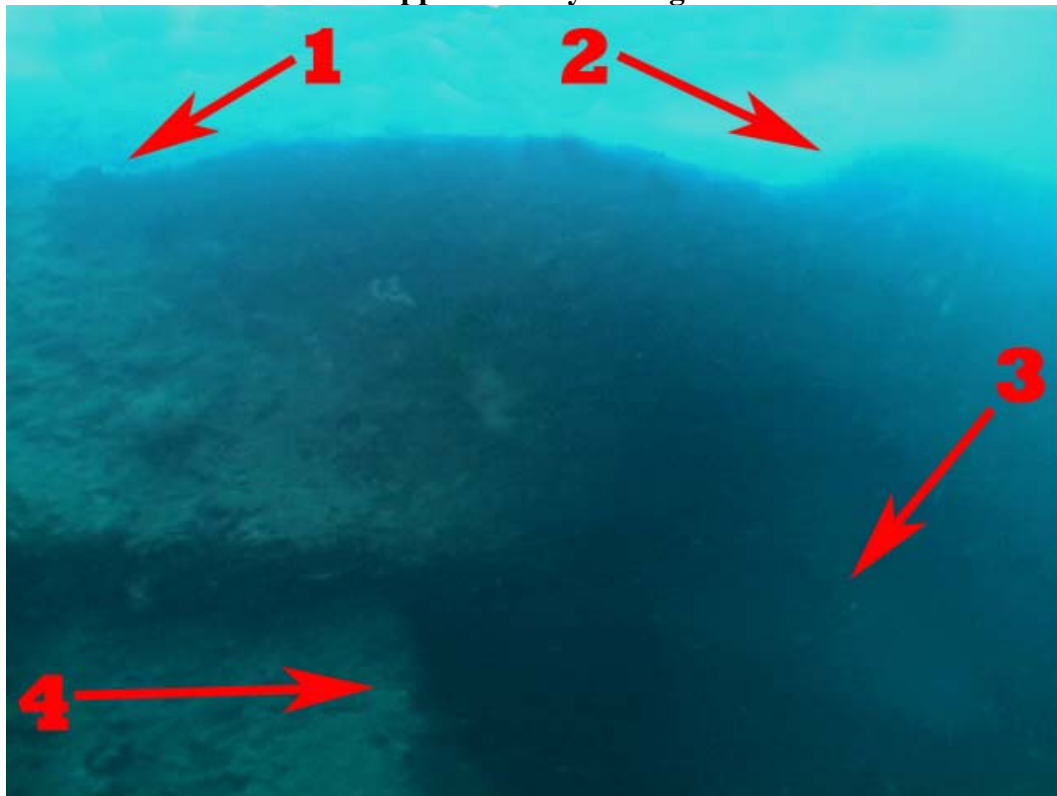
1) Forward end of Starboard Bilge Keel. 2) Buckle in Bilge Keel above torpedo hole. 3) Upper portion of torpedo hole. 4) Forward edge of torpedo hole.

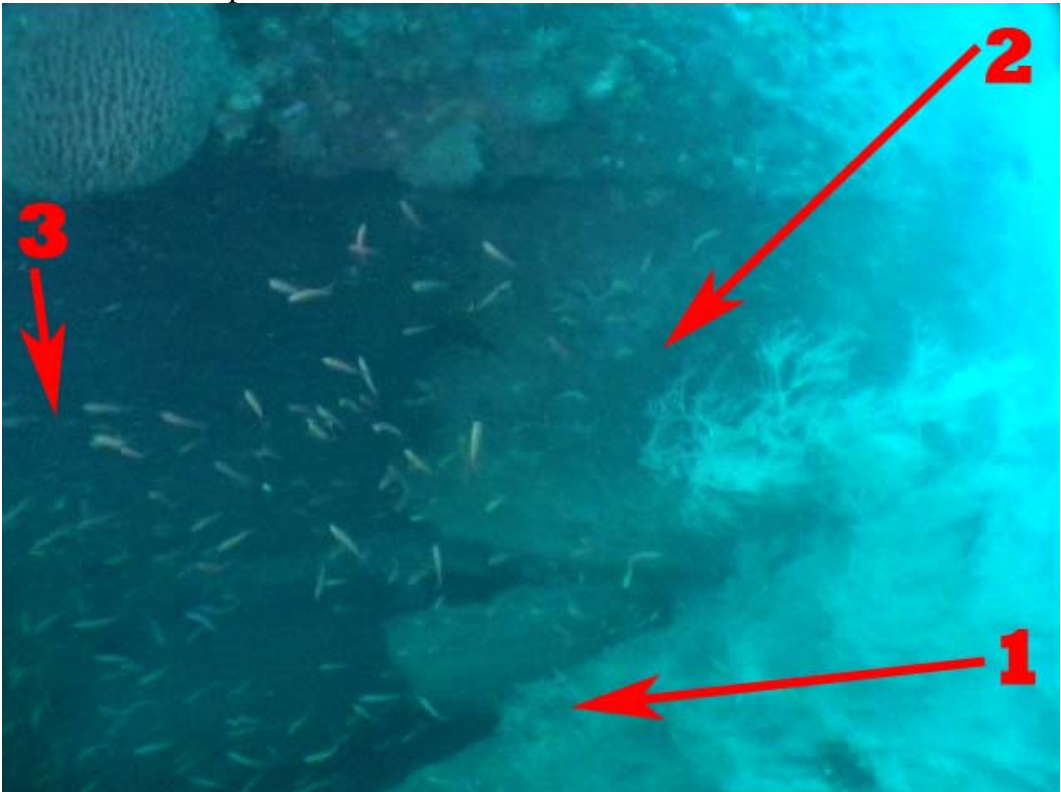
1) Bottom edge, Armour Belt. 2) Bent in hull plates, aft edge of hole. 3) Torpedo hole.

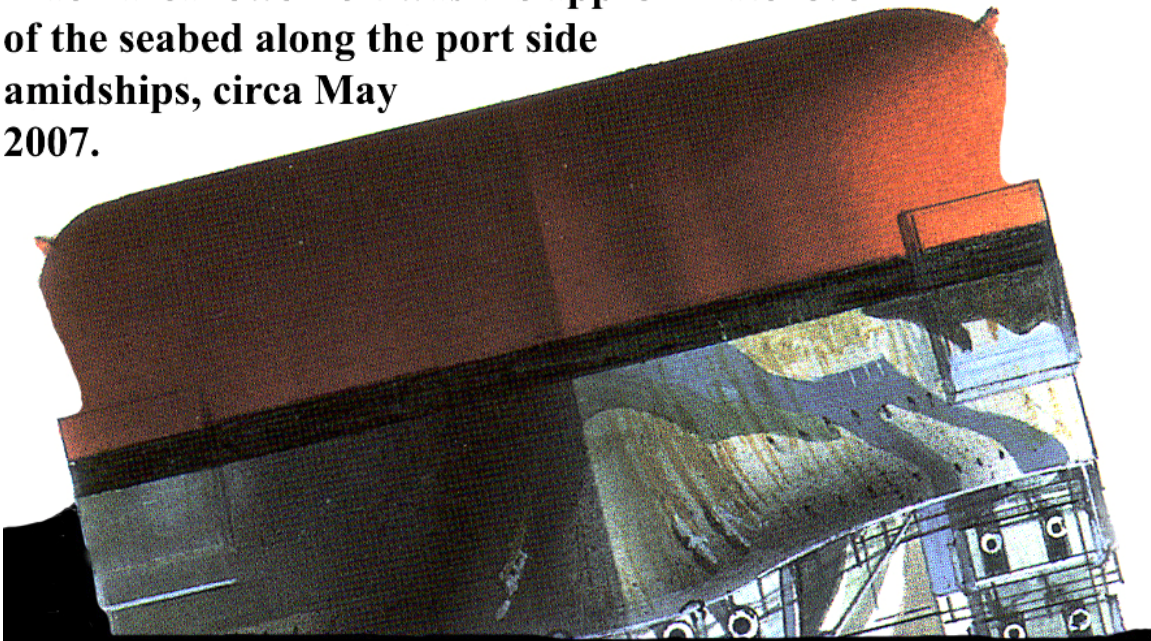
Black area lower left was the approximate level of the seabed along the port side amidships, circa May 2007.

WRECK OF *PRINCE OF WALES* LAYS ON AN ANGLE OF APPROX. 15° TO PORT. Concave indentations in hull below armour belt are shaped as above throughout the areas as described in paragraph at bottom of page 9. This damage, and more information on the stern damage, is discussed - and shown in more detail - in two separate reports accessed at bottom of linked page; http://www.pacificwrecks.com/ships/hms/prince_of_wales.html
